# TECH NOTE 016

**ISSUE DATE:** 30-May-05  
**EXEDY REF:** 016  
**REVISED DATE:** 19-Aug-05

## POOR CLUTCH RELEASE HOLDEN RODEO 2.8 LTR DIESEL TURBO

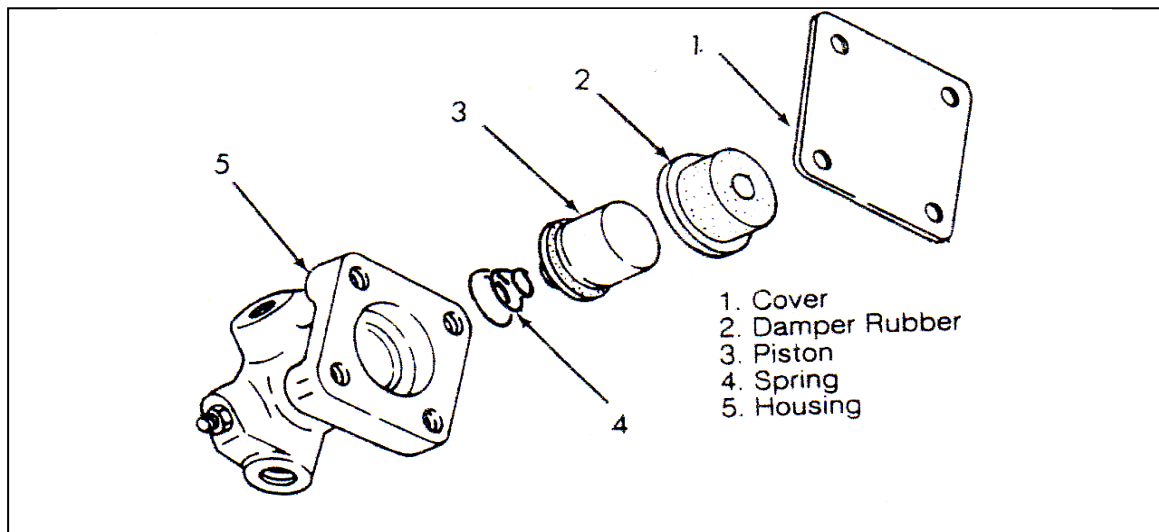
These vehicles are fitted with a Clutch Damper similar to that illustrated between the Clutch Master Cylinder and the Slave Cylinder.

It has been found that the Clutch Damper has been the cause of the problem, with the cup bypassing fluid and or the Damper Rubber compressing, which in turn restricts the fluid flow necessary to obtain the required slave cylinder travel.

Should you experience the subject concern, if you find you are able to lever the fork a little further, and the clutch releases correctly then the concern is likely to be the Clutch Damper.

To test if the Clutch Damper is at fault, make an hydraulic line to bypass the Damper, or use a suitable size joiner, if the clutch then operates correctly, the Clutch Damper should be replaced. It has been found replacement of the cup only in the Damper has not rectified the concern.

EXEDY Australia recommends that it is important the Damper is replaced and not substituted by the hydraulic bypass line or joiner.
