TECH NOTE 029

ISSUE DATE: 28-May-08
EXEDY REF: 029

Ford Ranger & Explorer Clutch Non Release

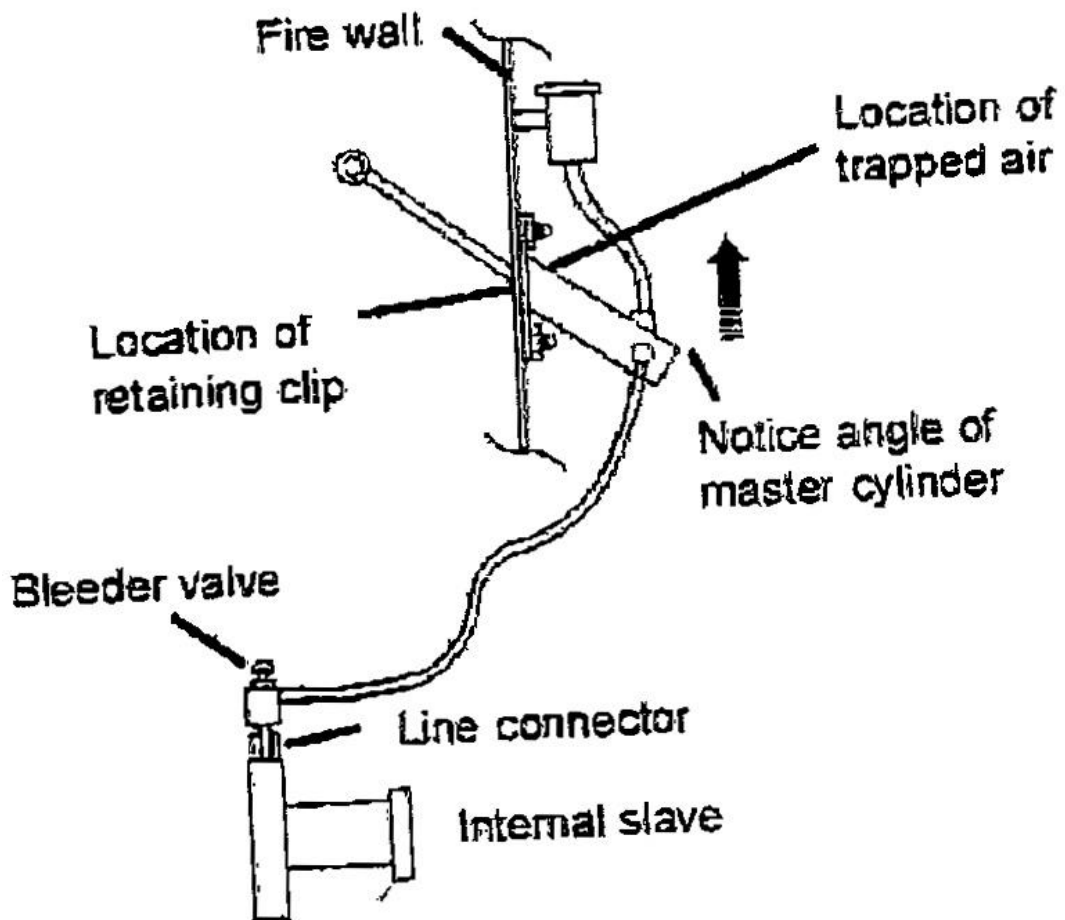
Air trapped in the hydraulic release system.

As a result of the clutch master cylinder location on the fire wall, air can remain trapped in the cylinder.

It is recommended the master cylinder be pre bled prior to installation in the vehicle. It has been reported that successful bleeding can be achieved by raising the front of the vehicle to an angle that allows the air to escape to the delivery line end of the cylinder.
