# TECH NOTE F

**ISSUE DATE:** 10-Dec-04  
**EXEDY REF:** F  
**REVISED:** 26-Jun-07

## VN COMMODORE FORK RATTLE

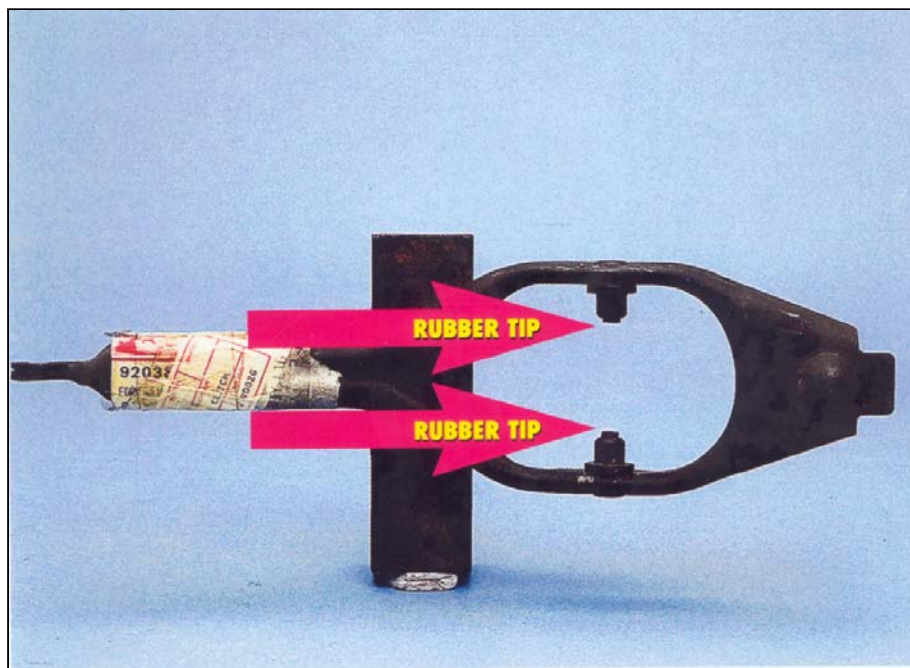
It has been brought to our attention that after a new clutch kit has been fitted that contains bearing part number BRG 2204 or BRG 2110, a rattle from the bearing and clutch fork area is apparent.

The design of the fork and the window of the bell housing where the fork protrudes cause the fork to drop and rattle against the window of the bellhousing when the fork absorber rubbers are worn.

Check clutch fork rubber absorber bushes as per the diagram and in the event that these bushes are worn, they must be replaced.

**NOTE:** Bearing must be a tight fit

Replacement absorber rubbers genuine part number 3994273 two of (2) are required.
