TECH NOTE H

ISSUE DATE: 10-Dec-04
EXEDY REF: H
REVISED: 15-Aug-05

**GMH/NISSAN CLUTCH KIT NSK-6336,
NSK-6863, NSK- 6921**

PROBLEM: EXCESSIVE FREE TRAVEL AND CLUTCH NON RELEASE

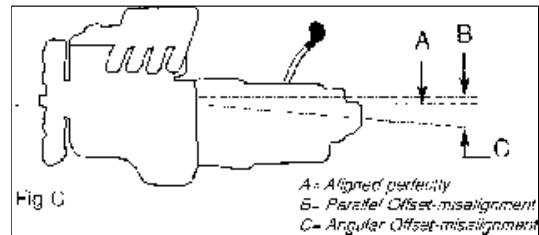
PROBLEMS: PREMATURE CLUTCH FAILURE CAUSED BY MISALIGNMENT (FIG C).

The tin plate located between the motor and the gearbox surfaces (as shown below with use of arrow Fig B) must be cleaned and aligned perfectly on the dowel pins and bolts when mating gearbox to motor.

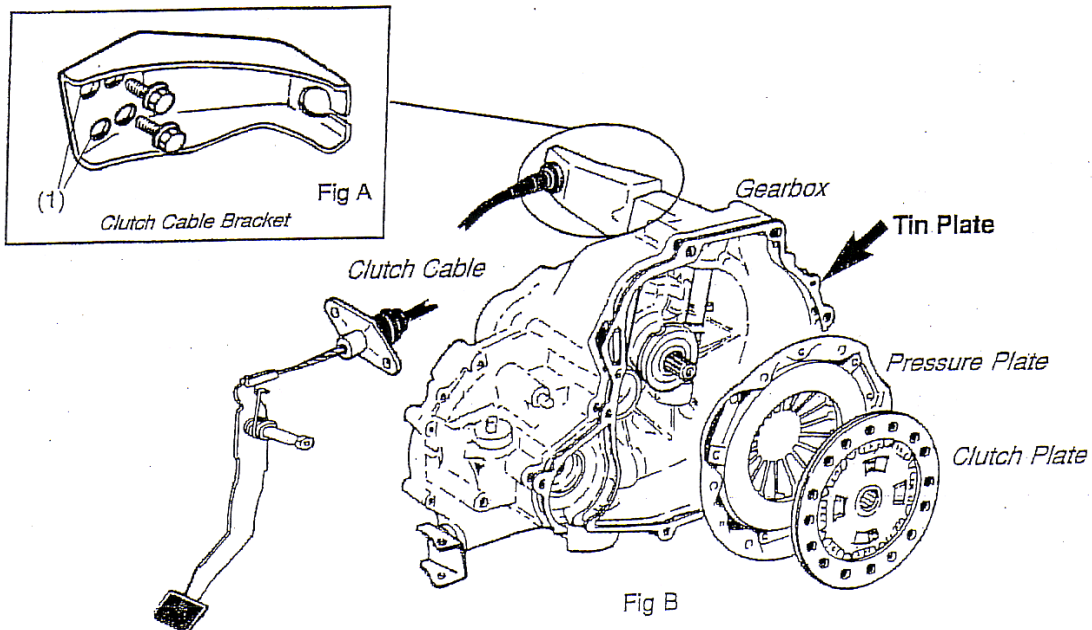
Any misalignment will result in damage of side plate, springs and hub of the clutch disc. This will lead to total clutch failure.
