TECH NOTE H

**GMH/NISSAN CLUTCH KIT NSK-6336,
NSK-6863, NSK- 6921**

PROBLEM: EXCESSIVE FREE TRAVEL AND CLUTCH NON RELEASE

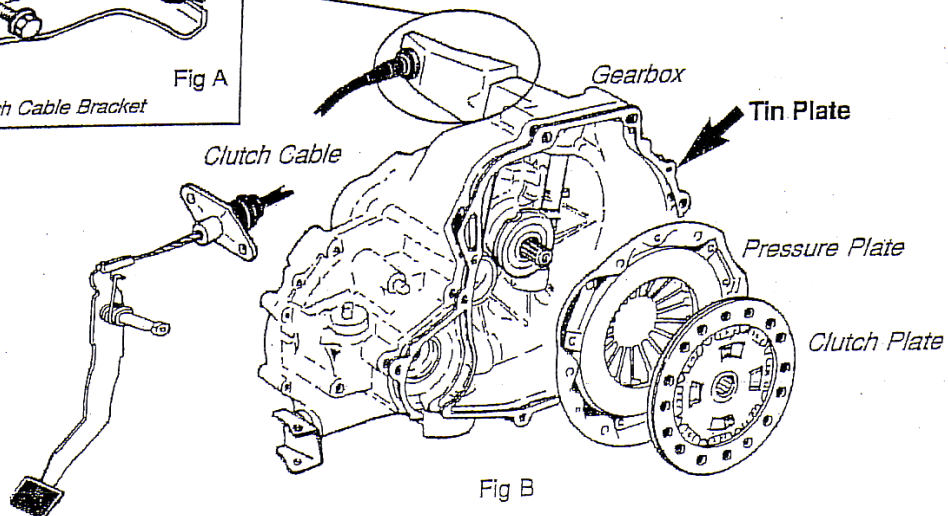
PROBLEMS: PREMATURE CLUTCH FAILURE CAUSED BY MISALIGNMENT (FIG C).

Any misalignment will result in damage of side plate, springs and hub of the clutch disc. This will lead to total clutch failure.
