TECH NOTE 009

ISSUE DATE: 16-Dec-04
EXEDY REF: 009
REVISED: 18-Aug-05

SLAVE CYLINDERS/BEARING ASSEMBLIES FORD F-SERIES

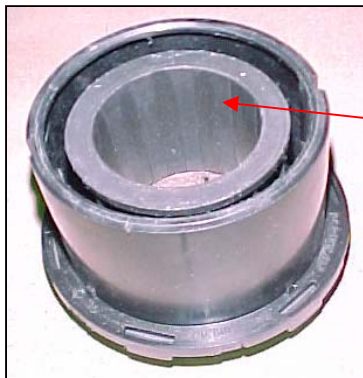
Old Style Bearing

No groove on the inside diameter slave cylinder side

Fig 1 and 2 are totally interchangeable. Fig 3 shows that the seal protector has become detached from the release bearing.

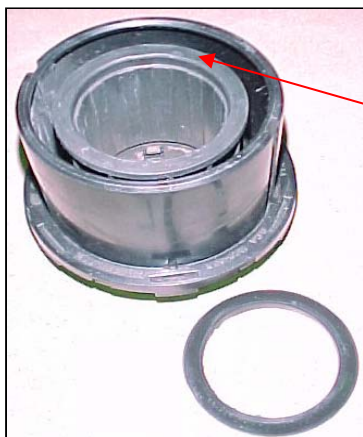
Fig 3

New Style Bearing

Seal protector missing from inside diameter

Seal protector

CAUTION: The seal protector Fig 4 could still be in the slave cylinder (see Fig 5 over page). If a new bearing is fitted and the old seal protector is still in the slave cylinder it will cause the seal to distort and the seal to leak.

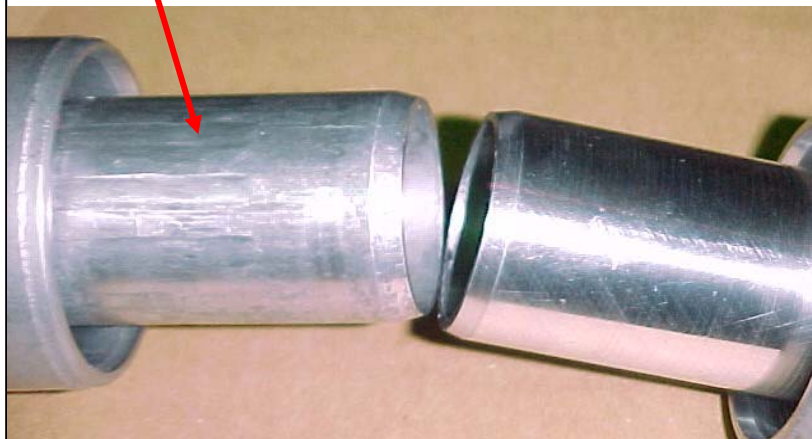
Fig 6

**OLD SLAVE CYLINDER NEW SLAVE CYLINDER
DO IT ONCE, DO IT RIGHT**
