TECH NOTE 041

**Holden
Barina/Combo XC
GMK-7346**

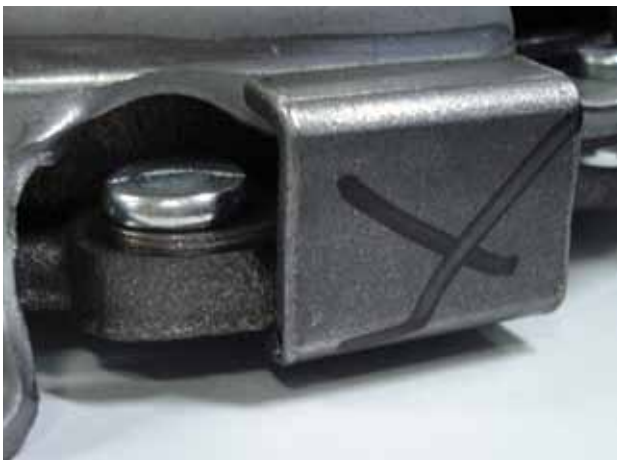
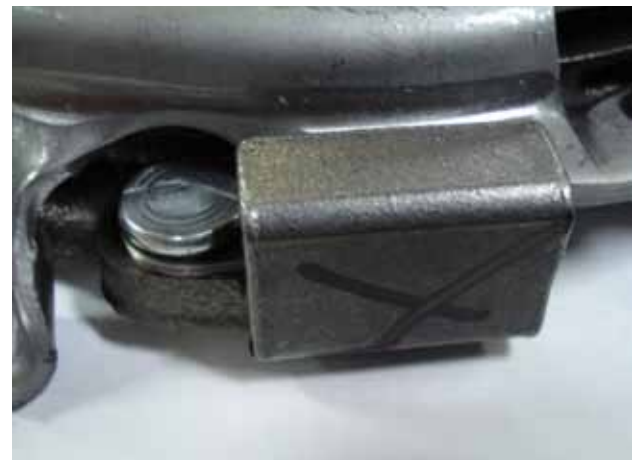
This kit may contain a cover assembly that has clips securing the pressure plate to the cover pressing during transport.

Failure to remove the clips will result in major damage to the bell housing.

It is imperative that these clips (three of) be removed after the cover assembly is bolted to the flywheel.
