TECH NOTE 5

NISSAN RELEASE BEARING CLIP

Thrust bearing retainer clip installation where the clip is the type shown in the photographs.

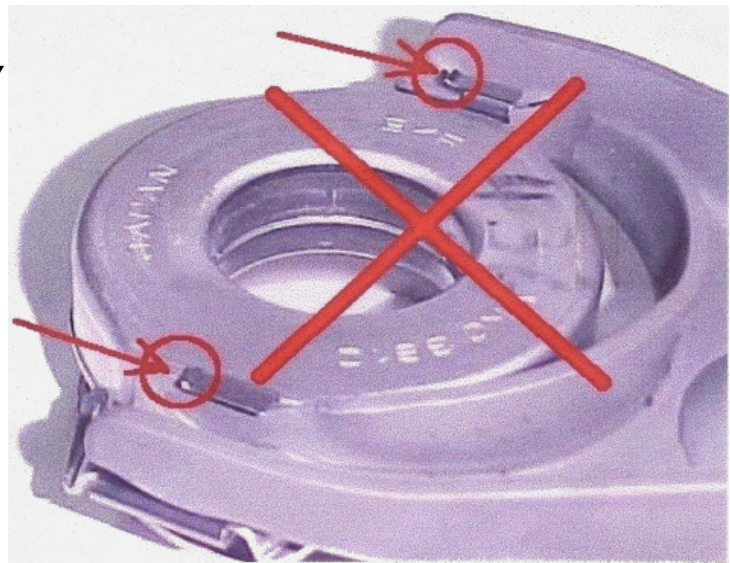
It has been brought to our attention that after a new clutch kit has been fitted that contains bearing number BRG2227 or BRG2215, concerns have been encountered including bad shudder, fork may shake around and sometimes is severe enough that the whole vehicle shakes and vibrates.

**BRG2227 & BRG2215
UPSWEEP OF CLIP FACING AWAY
FROM FORK - INCORRECT**

It has been found the thrust bearing must be fitted with the upswept section of the bearing retainer clips facing towards the fork. If not orientated correctly; symptoms described above can be experienced.

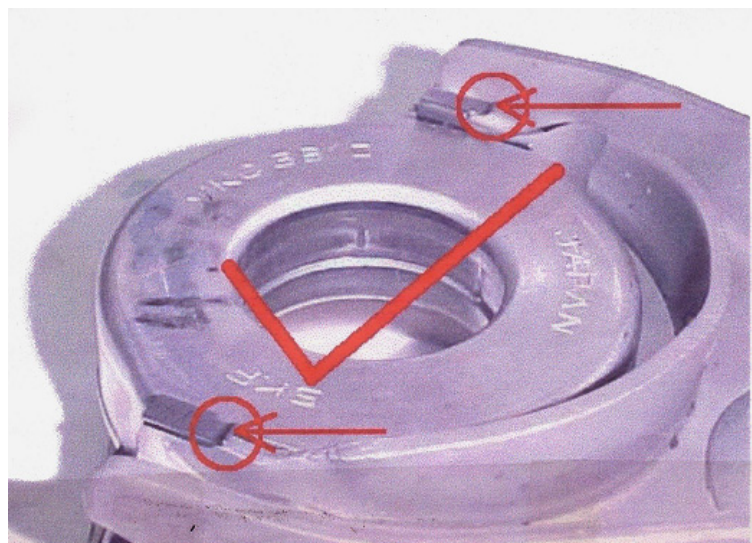
**BRG2227 & BRG2215
UPSWEEP OF CLIP FACE
TOWARDS FORK - CORRECT**
